STOP IT® Pipe Repair System Case History*

Idaho National Laboratory (INL) Advanced Test Reactor (ATR)

TRA-63 (TRA-605 WARM WASTE LINE)

Failure of Underground 4-Inch Radioactive Warm Waste Pipe and Leakage Discovered During Waste Piping Replacement Construction Project

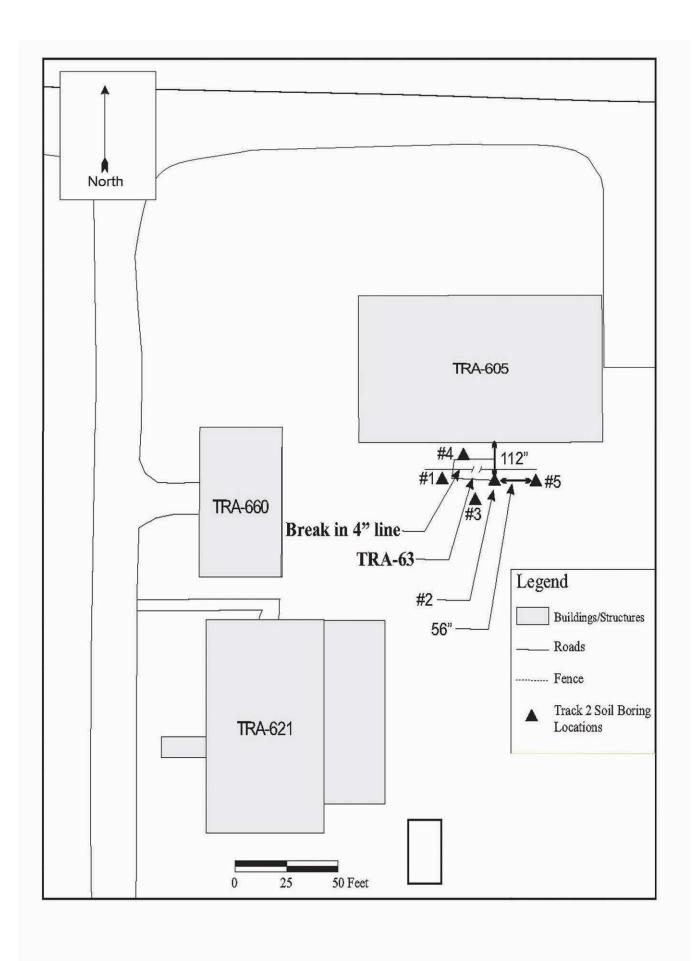
Hole Size: 1/2-in. offset shear with corrosion

"On October 9, 2001, during excavation of soil for the 30in. TRA-605 Warm Waste Pipeline Replacement Project, a radiological control technician detected contamination in a backhoe bucket load of removed soil. A survey of this soil with a hand-held frisker confirmed the presence of 30,000 dpm of contamination in the removed soil. Excavation continued to approximately 72 in. bgs. At this depth, the 4-in. warm waste pipeline (WDC-605) was uncovered, and water was observed seeping from around the 4-in, pipeline. As soil was removed from around the pipe, a puddle of approximately 3 gal of radioactively contaminated water formed in the hole around the pipe It became evident from an approximate 1/2-in. offset shear in the pipe that the 4-in. warm waste pipeline had broken. Further, the edges of the sheared pipe were corroded, indicating that the break may have existed for some time. The ratio of the surface area of the crack to the crosssectional area of the pipe was approximately 0.13; approximately 13% of the discharge through the pipe could potentially have been lost through the crack. Approximately 9,000 gal of warm wastewater flowed through this

"The source water to the 4-in. warm waste pipeline was stopped by turning off the pumps to the effluent radiation monitor system in the TRA-605 Process Water Building. Seepage from the pipe then stopped. A "Stop-It" patch, which is a water-activated polyurethane resin on fiberglass ([governmentfurnished equipment] pipe wrap repair system) by InduMar Products, Inc., was installed over the break on October 18, 2001. The 4-in pipeline was used until it was isolated on both the upstream and downstream ends in May 2002. The 4-in. pipeline was replaced with a new 4-in. pipeline in May 2002."
