STOP IT® Pipe Repair System Case Study

"Our ship is earning US\$10,000 per day and we cannot afford for any delays."

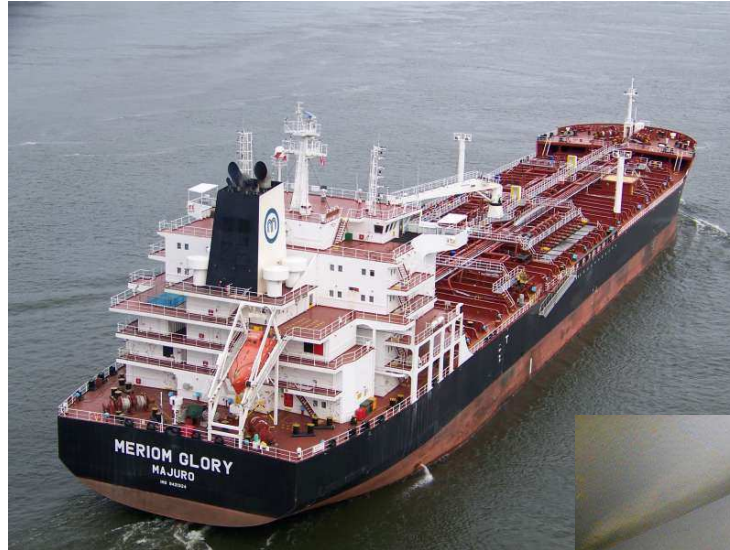
PROBLEM: The sea water outlet circuit of the Central Cooling System developed a leak caused by corrosion. Without adequate cooling certain parts of the engine, which are exposed to very high temperatures, would soon fail.

- *Process:* Engine Fluid Cooling
 - Salt Water
- *Operating Temp:* 86°F (30°C)
- *Operating Pressure:* 44 psi (3 bar)
- *Piping Substrate Material:* Steel
- *Pipe Diameter:* 4" (100 mm)
- *Defect:* Through wall hole
- *Defect Diameter:* 0.5" (12.7 mm)

M/T Meriom Glory was traveling at sea when the 1st Engineer identified a leak on the sea water outlet pipe which makes up part of the engine and machinery Central Cooling System. After identifying the leak and examining the substrate defect it was determined that the corrosive sea water had eaten a hole right through the pipe wall. Cutting out and replacing the defective section of pipe was not an option since the vessel was currently underway and the time involved in replacement would have meant days of lost production.

1st Engineer John Biscas immediately decided to use the STOP IT® PIPE REPAIR SYSTEM which the ship had on board. In a matter of minutes, not days, the problem was resolved!
